Hydrology Resource Assessment

Yolla Bolly Complex

Shasta-Trinity National Forest

September 22, 2008

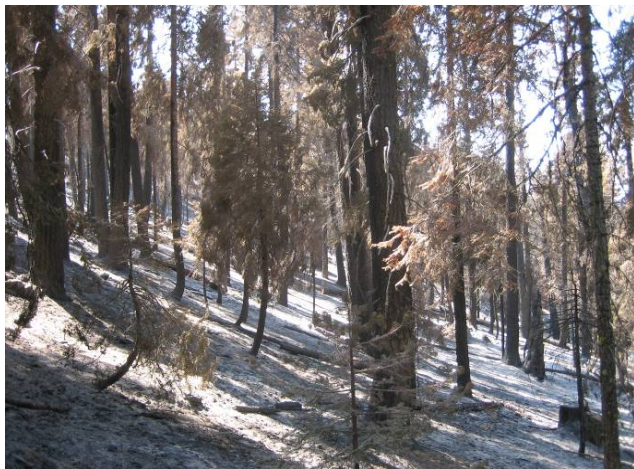
Moderate severity burn area in Deer Creek headwaters – Yolla Bolly Complex.

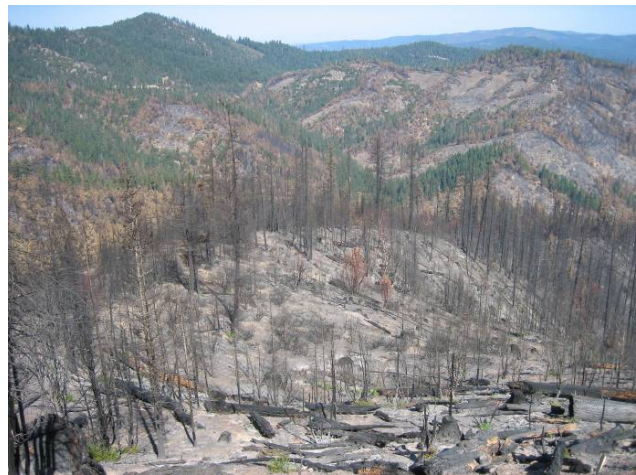
Trough Fire burn area on Rainbow Ridge.

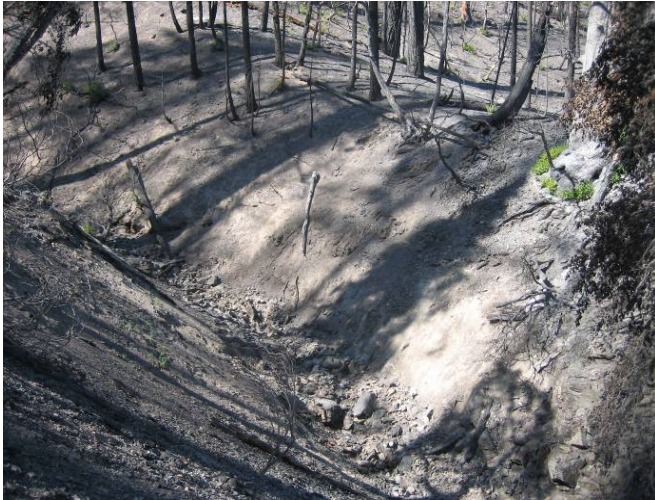
Intermittent stream channel burned at high severity below Rainbow Ridge – Trough Fire. Channel beds are armored with coarse colluvium and bedrock. All channels draining Rainbow Ridge were incised with steep inner gorge walls that were likely eroding prior to the fire.

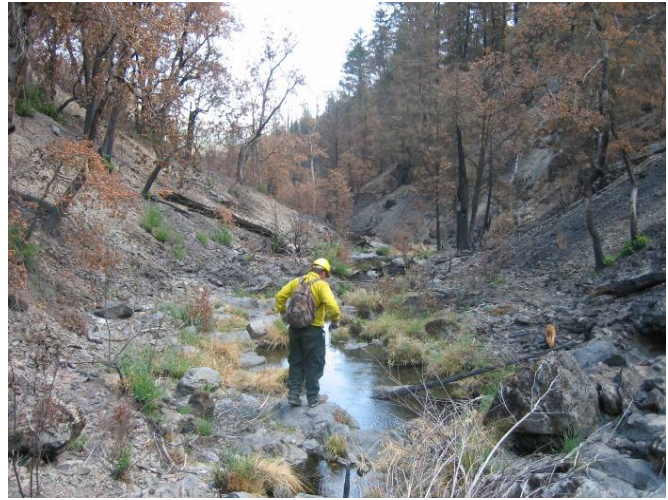
Small unnamed perennial stream tributary to Shell Mountain Creek. The Trough Fire burned hot within the riparian corridor. Riparian vegetation resprouting was evident along the entire surveyed channel length.

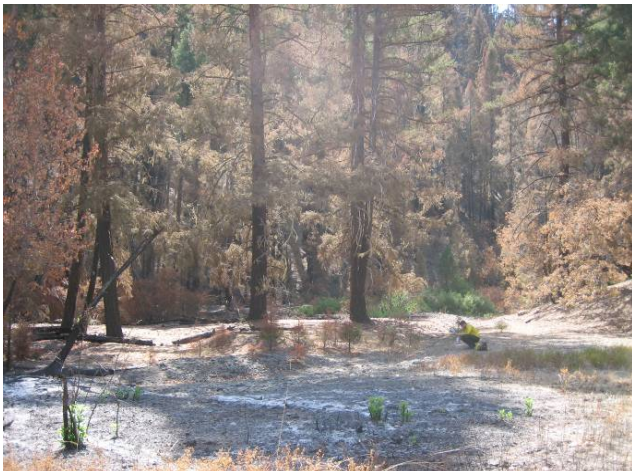
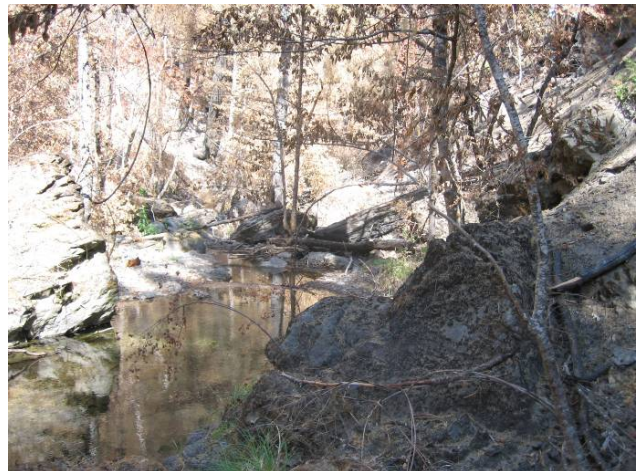
Old debris flow deposit on low gradient reach of unnamed tributary to Shell Mountain Creek within the Trough Fire burn area. This deposit was likely caused by a debris jam that formed in the bedrock constricted channel reach shown in the above right photograph.
